Prüfbericht-Nr.: <i>Test Report No.:</i>	21246623.002rev01	Auftrags-Nr.: <i>Order No.:</i>	21246623	Seite 1 von 14 Page 1 of 14	
Kunden-Referenz-Nr.: <i>Client Reference No.:</i>	1284407	Auftragsdatum: <i>Order date:</i>	28 May 2019		
Auftraggeber: <i>Client:</i>	GREENoneTEC Solarindustrie GmbH (for add. information see page 3)				
Prüfgegenstand: <i>Test item:</i>	Integrated Collector Storage				
Bezeichnung / Typ-Nr.: <i>Identification / Type No.:</i>	SUNPAD E				
Auftrags-Inhalt: <i>Order content:</i>	A collector reliability test in accordance with EN ISO 9806:2017 should be performed with the aim of certification.				
Prüfgrundlage: <i>Test specification:</i>	EN ISO 9806:2017 Solar energy - Solar thermal collectors - Test methods				
Wareneingangsdatum: <i>Date of receipt:</i>	02 August 2019				
Prüfmuster-Nr.: <i>Test sample No.:</i>	see "List of test samples"				
Prüfzeitraum: <i>Testing period:</i>	05 August 2019 – 16 October 2019

1	Name/Adresse des Herstellers <i>Name/Address of manufacturer</i>	GREENoneTEC Solarindustrie GmbH Energieplatz 1 9300 St. Veit/ Glan
2	Name/Adresse des Berichtsinhabers <i>Name/Address of owner of report</i>	GREENoneTEC Solarindustrie GmbH Energi

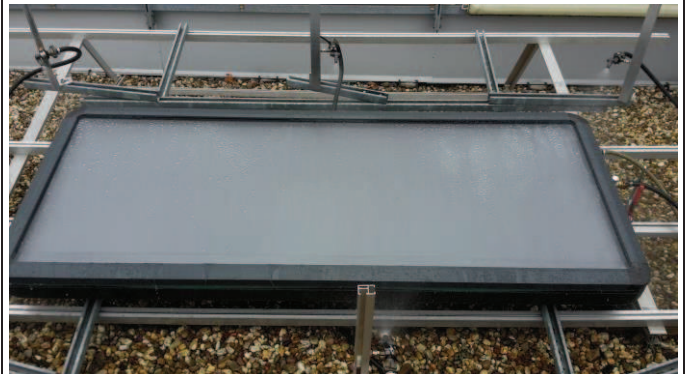
Rain Penetration

Test date [DD/MM/YYYY]		09/10/2019			—
Collector mounted on		Open frame			
Collector tilt angle [° from horizontal]		20			
Sample No.	Test duration [h]	Detection of water penetration by	Hours after spray [h]	Water ingress [g]	
HV2019004024	4	Visual inspection	4	-	P

Supplementary information: Integrated Collector Storage, water between closed cell insulation foam and water tank can drain completely.

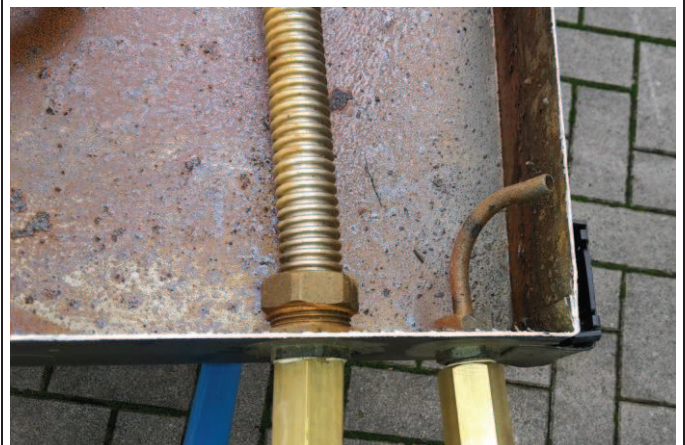
Endkontrolle

17	Final inspection			
Test date [DD/MM/YYYY]		09/10/2019 // 16/10/2019		—
Scale of potential problem		0 – No problem 1 – Minor problem 2 – Major problem ~ – Inspection to establish the condition not possible		
Sample No.	Collector component	Potential problem	Evaluation	—
HV2019004024	a) Collector box/fasteners	Cracking/wrapping/corrosion/ rain penetration	0	
			0	
HV2019004024	b) Mountings/structure	Strength/safety	0	
			0	
HV2019004024	c) Seals/gaskets	Cracking/adhesion/elasticity	0	
			0	
HV2019004024	d) Cover/reflector	Cracking/crazing/buckling/delamination/ wrapping/outgassing	0	
			0	
HV2019004024	e) Absorber coating	Cracking/crazing/blistering	0	
			0	
HV2019004024	e ²) Absorber tubes and headers	Deformation/corrosion/leakage/ loss of bonding	1	
			1	
HV2019004024	e ³) Absorber mountings	Deformation//corrosion	0	
			0	
HV2019004024	f) Insulation	Water retention/outgassing/ degradation	0	
			0	
Supplementary information:
